# Manhole Inspection Summary

Manhole # S23KK\_003MH

**Location** Address: **1356 NORTH AVE**

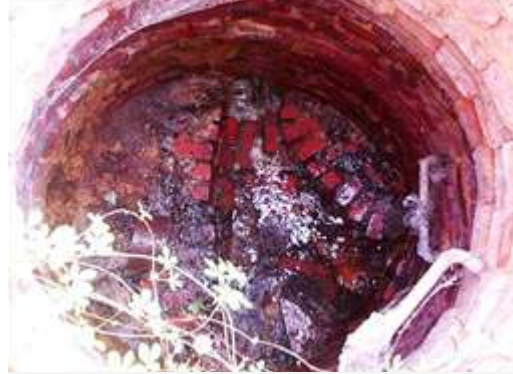
Top View

Corrode dsteps. Evidence of surcharge - Bench debris. Channel debris.

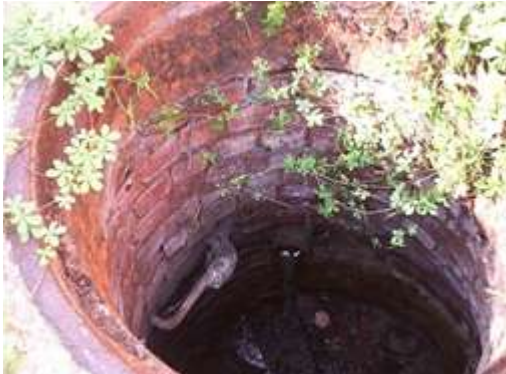
Defect

Frame leaks. Adjustment deterioration and infiltration. Corbel and Barrel infiltration - other side.

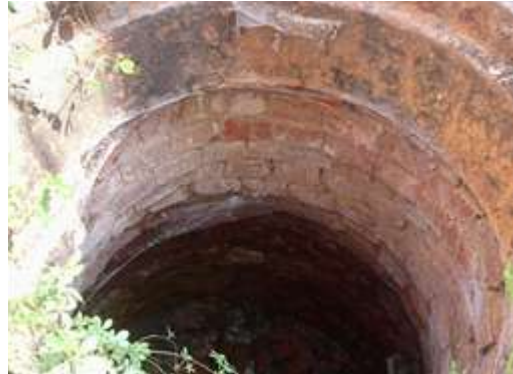
Defect

Frame leaks. Adjustment deterioration and infiltration. Corbel and Barrel infiltration.

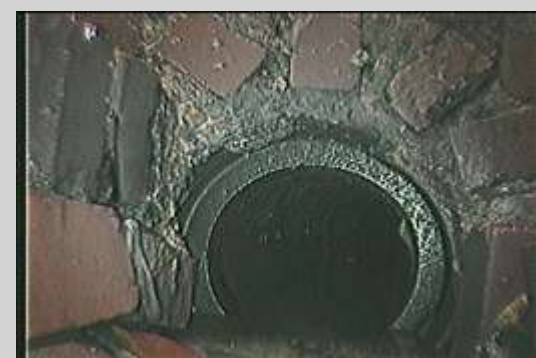
### 8 in. Circular Gravity Sewer Pipe Out @ 12 O'Clock

Channel deterioration.

Deposits: ☐ None ☒ **Mud** ☐ Sludge ☒ **Debris** ☐ Grease

Infiltration: **Evidence** Pipe Seal Cond: **Unknown**

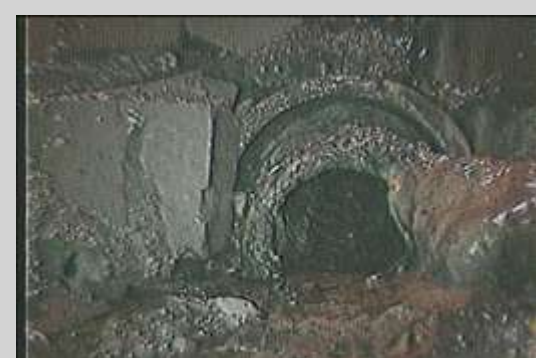
### 4 in. Circular Gravity Sewer Pipe In @ 3 O'Clock

Barrel deterioration and infiltration. Channel deterioration.

Deposits: ☐ None ☒ **Mud** ☐ Sludge ☒ **Debris** ☐ Grease

Infiltration: **Evidence** Pipe Seal Cond: **Unknown**

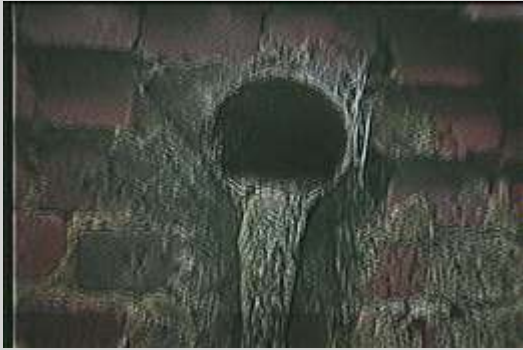
Pipe In @ 6 O'Clock

Barrel deterioration, root intrusion and infiltration.

Deposits: ☐ None ☒ **Mud** ☐ Sludge ☒ **Debris** ☐ Grease

Pipe Seal Cond: **Roots**
